## Detailed Survey Results

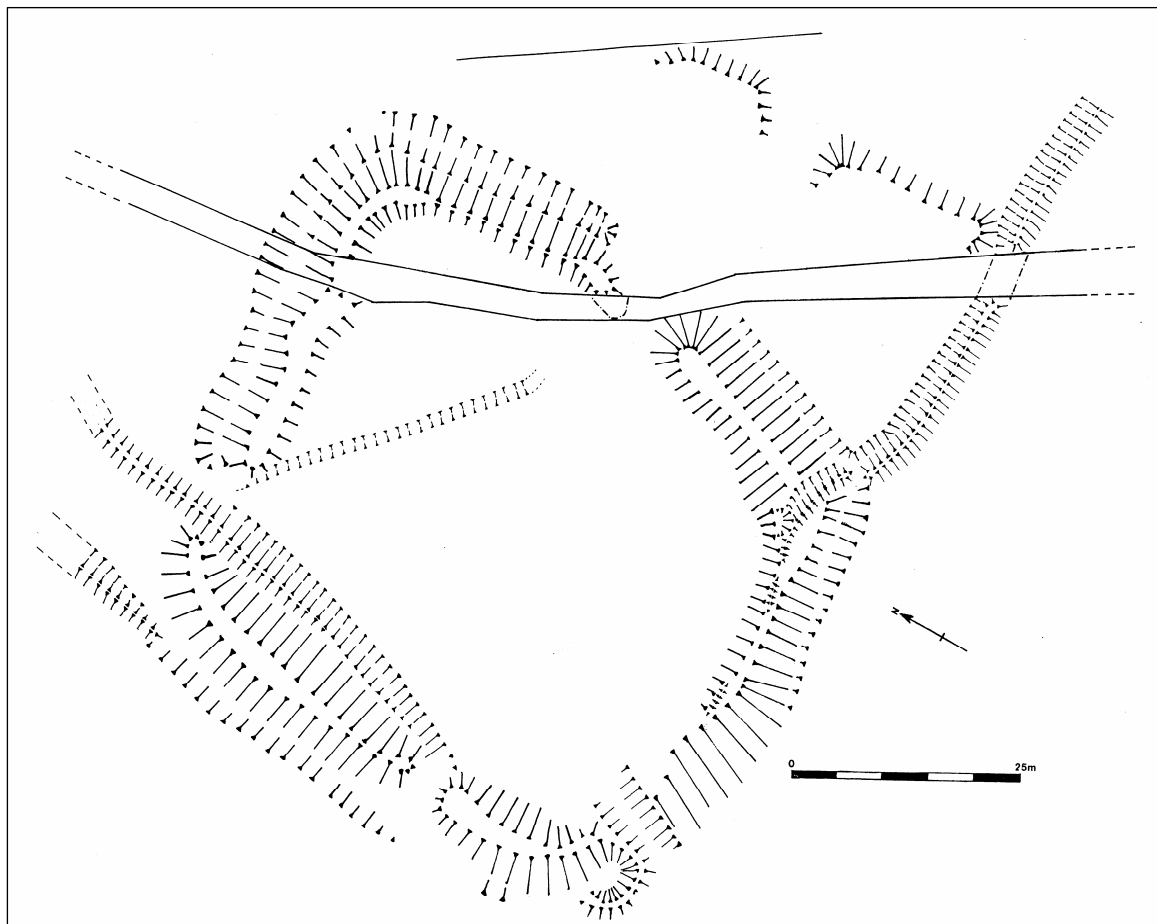
**Figure 2:** Detail Survey Plan of rectangular settlement enclosure.

The detailed plan of the rectangular settlement enclosure replaces one of an earlier date and was centred particularly on how the enclosure related to the field systems to the south. The plan provided further information on the extent of erosion upon the enclosure. An area that has been affected by substantial erosion was recorded along the southern course of enclosure defences. The course of the defensive ditch disappears almost entirely from view due to the collapse material from the earthwork bank, which itself has eroded to form a terrace. It is only when forming the southeast and southwest corners that these earthworks become more pronounced.

The defensive bank and ditch are most substantial along the course of the eastern and northern edges of the enclosure where the bank stands 2-3m high and up to 5m wide. The ditch survives at a depth of 1-2m and measures between 3-5m wide. The original

The planned survey indicates a great deal of disturbance to the feature's western edge and southwestern corner. This disturbance was a cause of quarrying on the site, probably during the post-medieval period. The quarrying was concentrated around the southwest corner, the result of which has seen the corner's partial removal. The ditch has been entirely removed within this area, as have two sections of the bank defences.

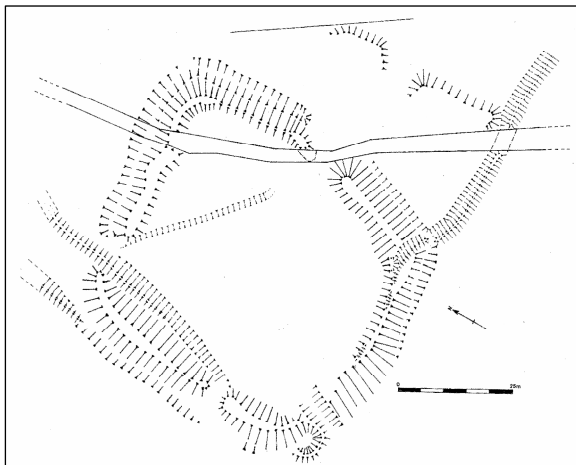
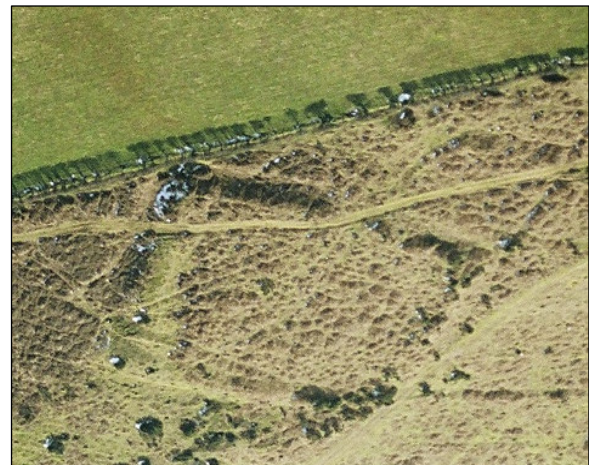
Further information gained from the survey relate to the enclosures association to the surrounding field systems. On at least three instances the enclosure is directly affected by later field systems as the boundaries cross into the enclosures interior or follow the course of the defences. One of the most prominent boundaries approaches the enclosure from the east and makes contact with the southeast corner where it then runs onto to the top of the defences riding the southern defences.

The second and third field boundaries recorded relate to two parallel boundaries HSM 44128 recorded during the walkover survey. The two approach from the north toward the enclosure's northwest corner. The western most comes to an end on making contact with the enclosure ditch whereas the eastern boundary enters the interior of the enclosure through a break in the earthworks aligned south toward the southwest corner before it becomes untraceable.

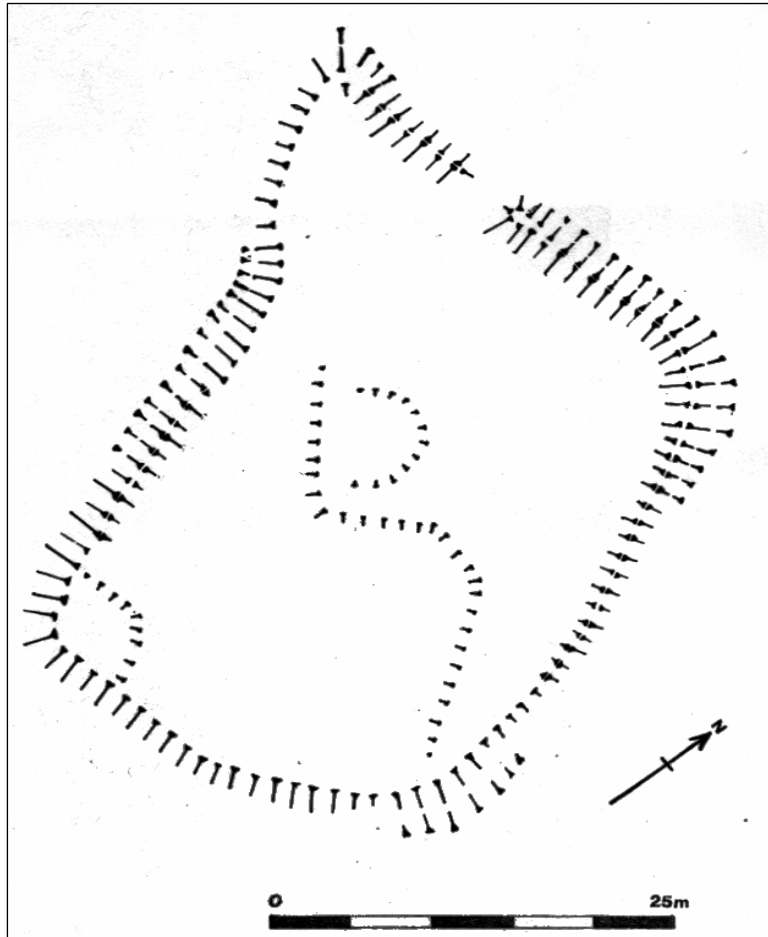
**Figure 3:** Detail Survey Plan of sub-rectangular enclosure.

The opportunity to carry out detailed survey allowed for the recording of the previously unknown sub-rectangular enclosure HSM 43902. The enclosure is aligned northwest to southeast and constructed upon a natural terrace within the southwest corner of the common. The enclosure measures c.35m north-south by 25m east-west. The site is enclosed by a bank and ditch earthwork that varies in condition due to gradual erosion. The survey itself was performed under less favourable conditions due to intense bracken coverage that masks the site. As such a proportion of the enclosure will have gone unrecorded due to poor visibility.

Within the interior of the enclosure a series of at least three terraces were recorded. The largest is aligned on a sinuous course from south-eastern corner towards the north-western corner. On the eastern edge of the sinuous terrace is a second semicircular terrace/ platform. Within the interior is a concentration of surface stone that may indicate the site of an internal structure. The third terrace/platform is visible within the southwest corner of the enclosure; again semicircular in profile though there are no surface features.

The entrance to the enclosure is unclear due to the extensive bracken coverage and general erosion on the enclosure; a possible site was recorded within the north of the enclosure.
